ADVANCED METALLIC AIR VEHICLE STRUCTURE PROGRAM

SECOND INTERIM REPORT

*GENERAL DYNAMICS
CONVAIR AEROSPACE DIVISION
FORT WORTH OPERATION*

TECHNICAL REPORT AFFDL-TR-73-77

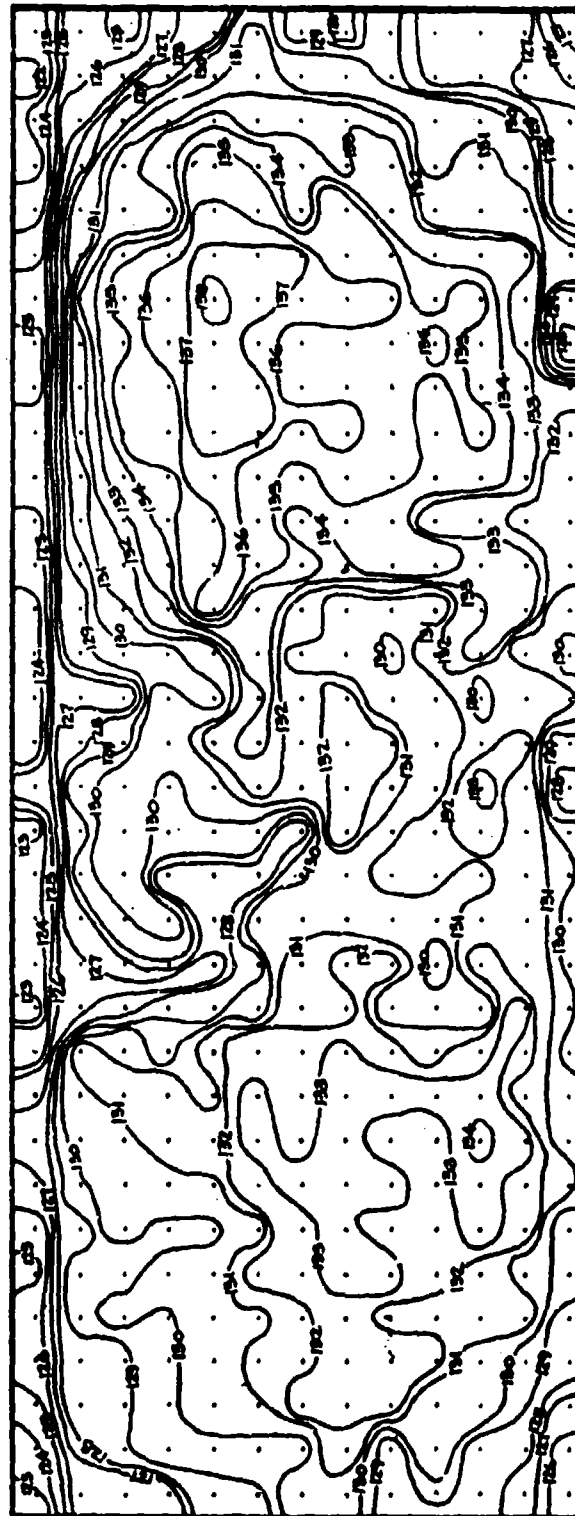
SHEET 1-3 HT 304324-25

38 3/4" X 103 1/4"

MAX	.1385	RANGE	.0170
MIN	.1215	σ	.004
AVG	.1303	POINTS	442

SHEET THICKNESS VARIATION BETA C TITANIUM ALLOY 1/8" SHEET (ROLLED AND PICKLED)

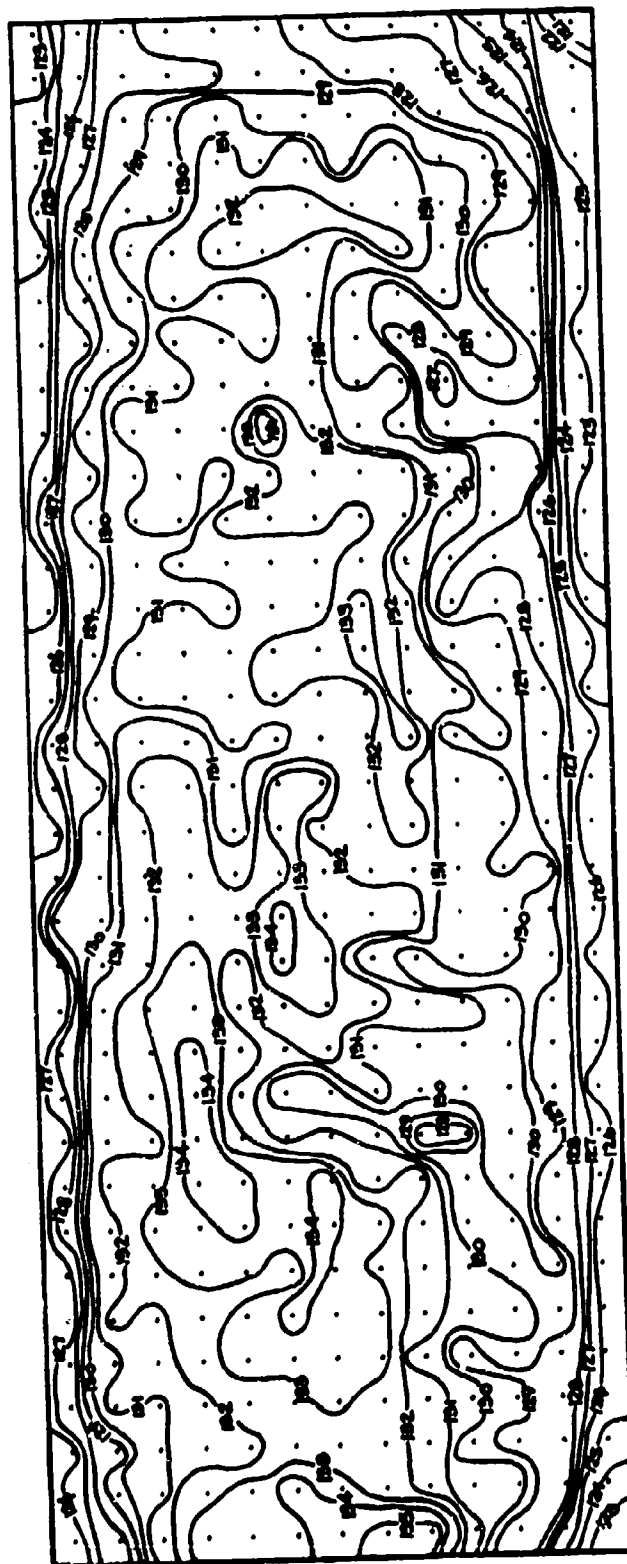
SHEET 1-5 HT 304324-25

39" X 103 1/2"

MAX	.135	RANGE	.0145
MIN	.1205	σ	.0029
AVG	.1295	POINTS	455

SHEET THICKNESS VARIATION BETA C TITANIUM ALLOY 1/8" SHEET (ROLLED AND PICKLED)

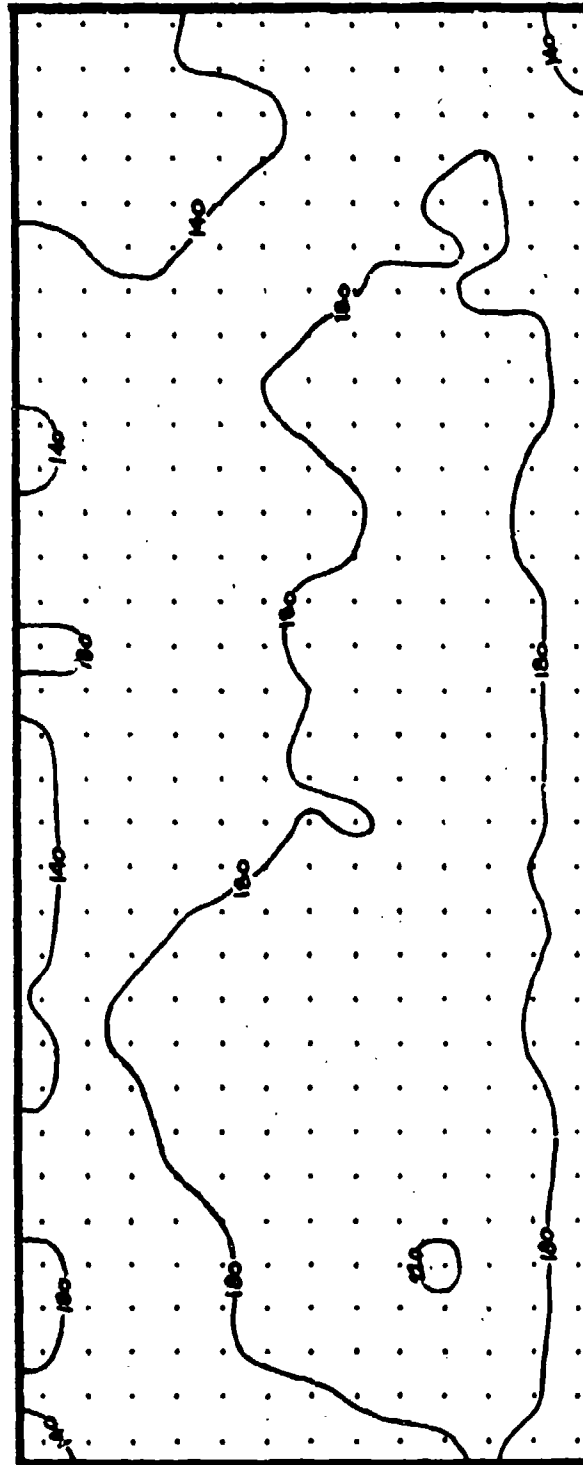
SHEET 1-4 HT 304324-25

38 3/4" X 97"

MAX	.221	RANGE	.098
MIN	.123	σ	.023
AVG	.1736	POINTS	429

SHEET FLATNESS VARIATION BETA C TITANIUM ALLOY 1/8" SHEET (ROLLED AND PICKLED)
